Manhole Inspection Summary

Manhole # S35KK_007MH

Location Address: **124 TRENTON ST**

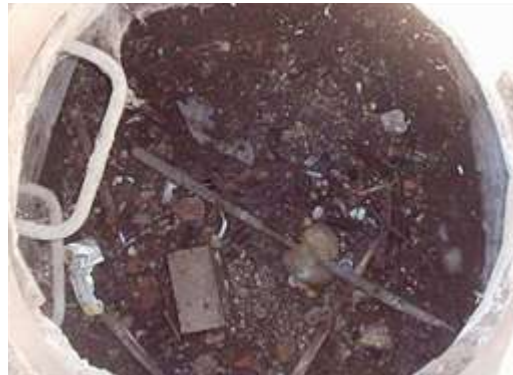
Top View

Channel Material: **Brick** ☐ Parged ☒ **Debris** (not Condition related)

Channel debris.

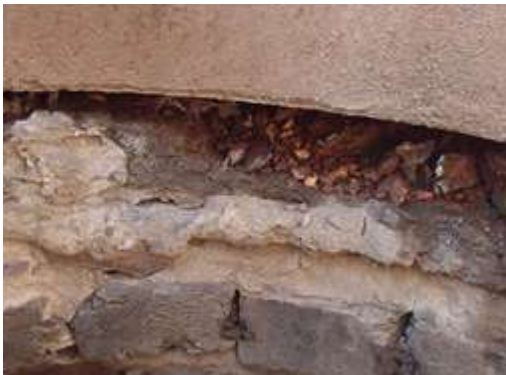
Defect

Condition: ☐ Sound ☐ Cracked ☐ Root Intrusion ☐ Loose Brick ☒ **Deteriorated**

Infiltration: ☐ None ☒ **Joint** ☐ Cracks ☐ Mortar ☐ Roots ☒ **Wall**

Frame leaks. Corbel deterioration and infiltration.

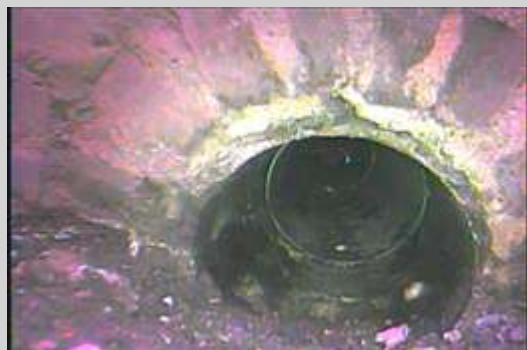
Pipe Out @ 12 O'Clock

8 in. Circular Gravity Sewer

Deposits: ☐ None ☒ **Mud** ☐ Sludge ☒ **Debris** ☐ Grease

Silt Depth: **0.5** (in.)

Deposits Extent: **Light**

Infiltration: **Evidence**
